## Common Irregularities Encountered In the Issue of a Fire Services Certificate

Premises: Non-Designed School

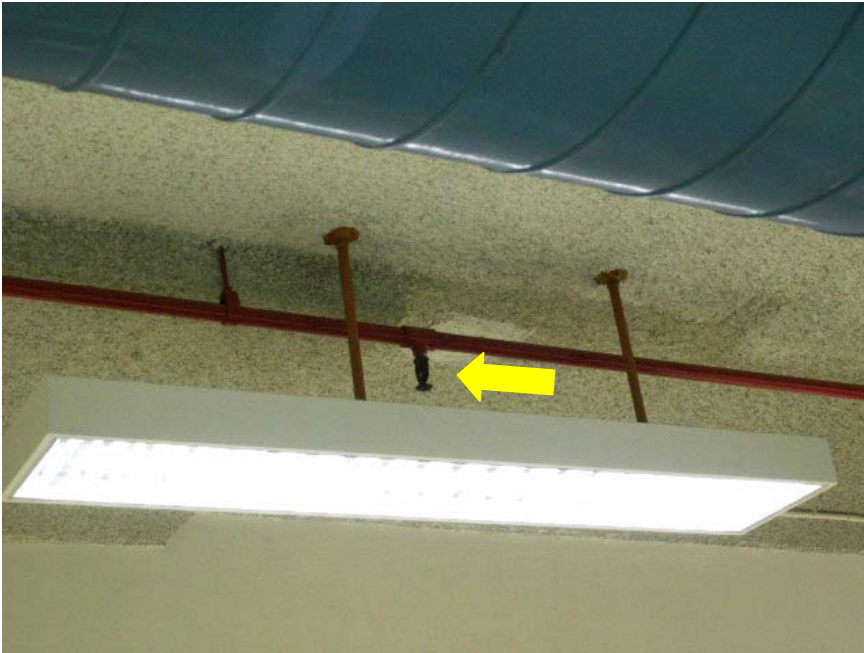
Obstruction to sprinkler head

Subject	Irregularities/Suggestions
Irregularities	<b>Relocation of sprinkler heads without the production of a valid FSI/314A or FSI/314B</b>
Advice	For every minor alteration and addition works on the sprinkler system of the existing premises, a certificate of FSI/314A or FSI/314B as appropriate must be submitted by the Fire Service Installation Contractor to the Fire Services Department prior to the commencement of works. During the compliance inspection, a copy of the certificate of FSI/314A or FSI/314 B duly stamped by the Fire Services Department must be produced for verification purpose.
Irregularities	<b>Inadequate coverage of sprinkler heads or obstruction to sprinkler heads</b>
Advice	The main function of sprinkler heads is to suppress a fire at the incipient stage upon actuation. According to international standards, sprinkler heads should be evenly installed throughout the entire area under protection. For decoration works involving the removal or addition of partitioning walls, adequate coverage of sprinkler heads must be maintained and checked by a Registered Fire Service Installation Contractor. In any case, the operation of sprinkler heads should not be obstructed by any decoration, false ceiling, structure, stacking up of goods, etc.

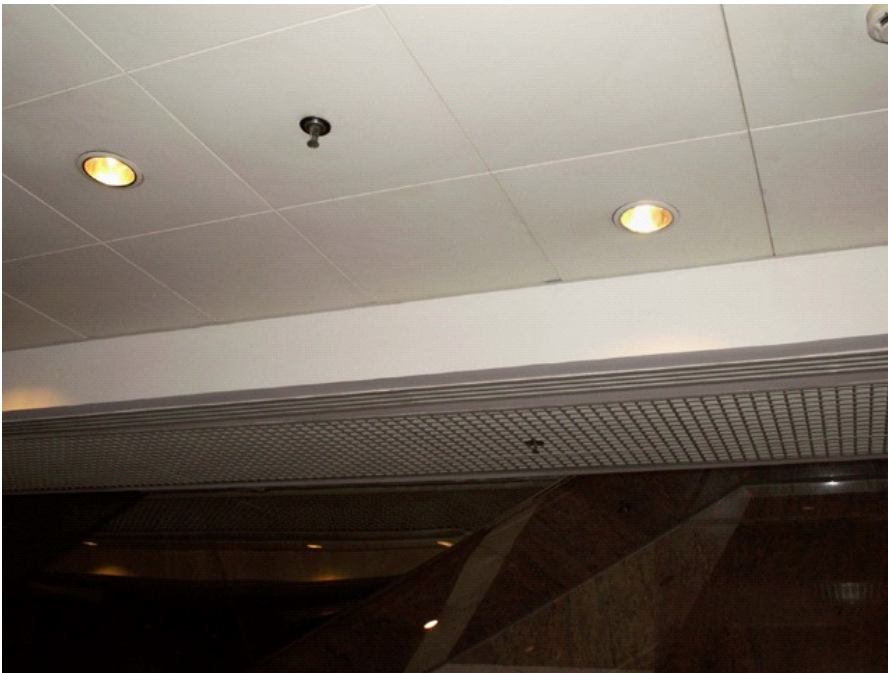
Sprinkler head clear of any obstruction

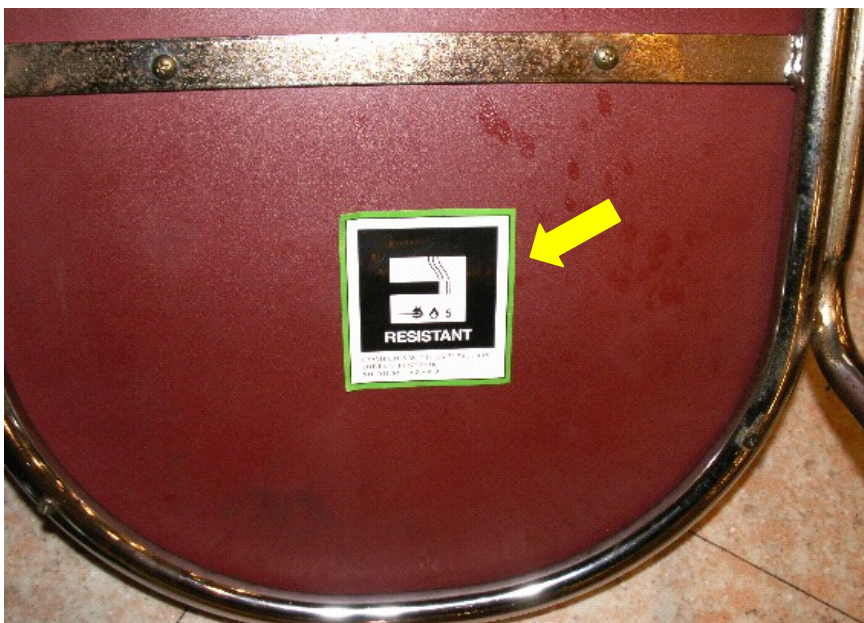
PU foam filled furniture comply with the British Standard 7176 :1995 (medium hazard) or British Standard 7177: 1996 (medium hazard)

Irregularities	<b>No documentary proof for fabric of PU foam filled furniture</b>
Advice	According to licensing requirements, all PU foam filled furniture should comply with the British Standard 7176 :1995 (medium hazard) or British Standard 7177: 1996 (medium hazard). For full compliance with PU foam filled requirements, a test certificate from recognized laboratory and an invoice from the supplier or manufacturer should be produced for verification purpose.
Irregularities	<b>Exit signs not conform to Fire Services requirements</b>
Advice	The design of the exit sign should be in accordance the current fire safety requirements.

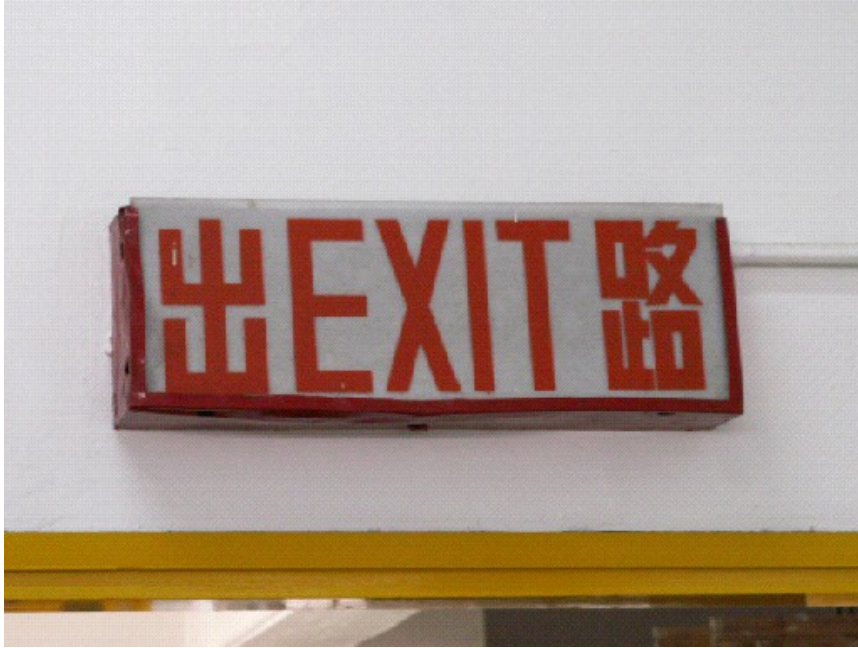
Exit sign not conforms to Fire Services requirements

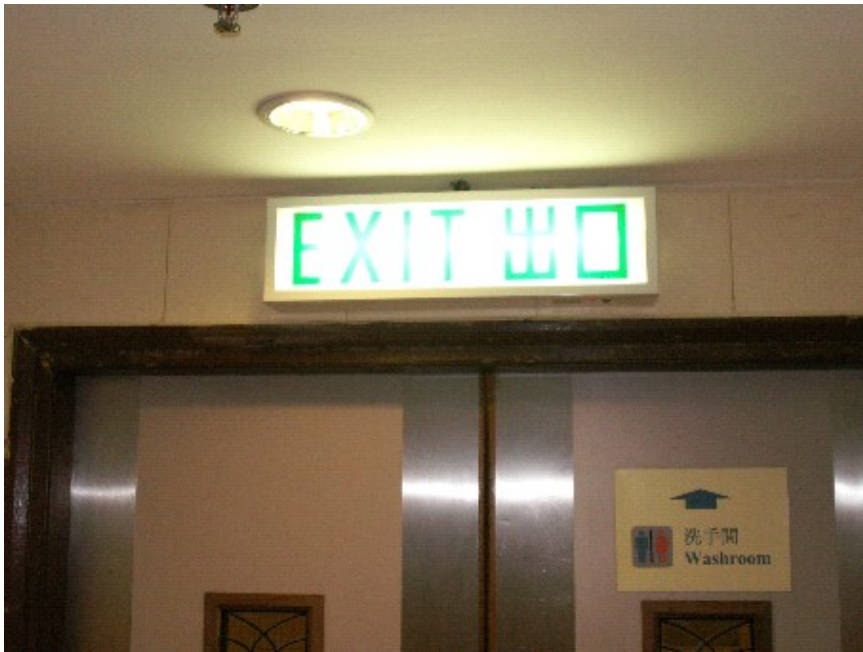
Exit sign conforms to Fire Services requirements
