## Common Irregularities Encountered In the Issue of a Fire Services Certificate

Premises: Non-local Higher and Professional Education Course operating in Non-exempted Premises

## Example of Common Irregularities

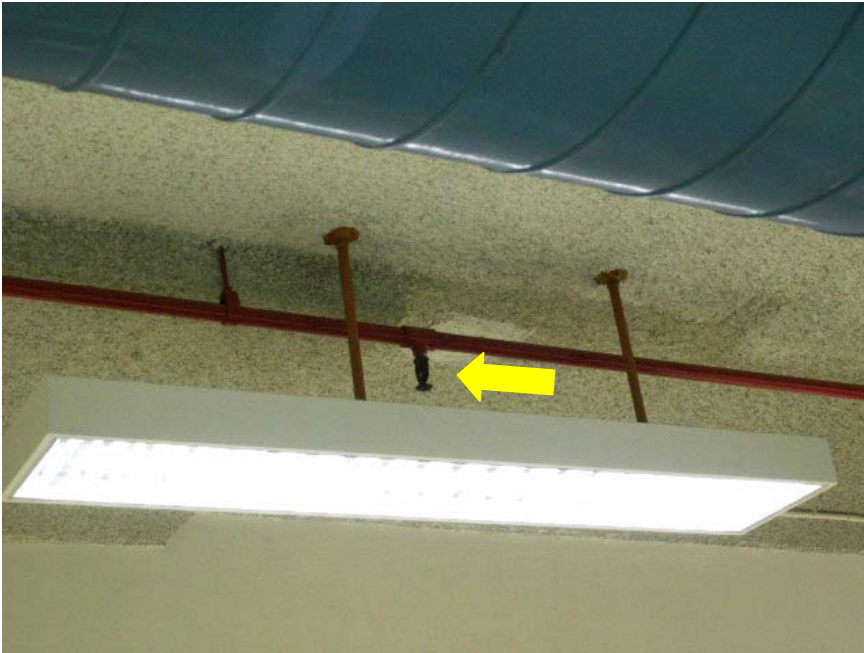
Obstruction to sprinkler head

Subject	Irregularities/Suggestions
Irregularities	<b>Relocation of sprinkler heads without the production of a valid FSI/314A or FSI/314B</b>
Advice	For every minor alteration and addition works on the sprinkler system of the existing premises, a certificate of FSI/314A or FSI/314B as appropriate must be submitted by the Fire Service Installation Contractor to the Fire Services Department prior to the commencement of works. During the compliance inspection, a copy of the certificate of FSI/314A or FSI/314 B duly stamped by the Fire Services Department must be produced for verification purpose.
Irregularities	<b>Inadequate coverage of sprinkler heads or obstruction to sprinkler heads</b>
Advice	The main function of sprinkler heads is to suppress a fire at the incipient stage upon actuation. According to international standards, sprinkler heads should be evenly installed throughout the entire area under protection. For decoration works involving the removal or addition of partitioning walls, adequate coverage of sprinkler heads must be maintained and checked by a Registered Fire Service Installation Contractor. In any case, the operation of sprinkler heads should not be obstructed by any decoration, false ceiling, structure, stacking up of goods, etc.

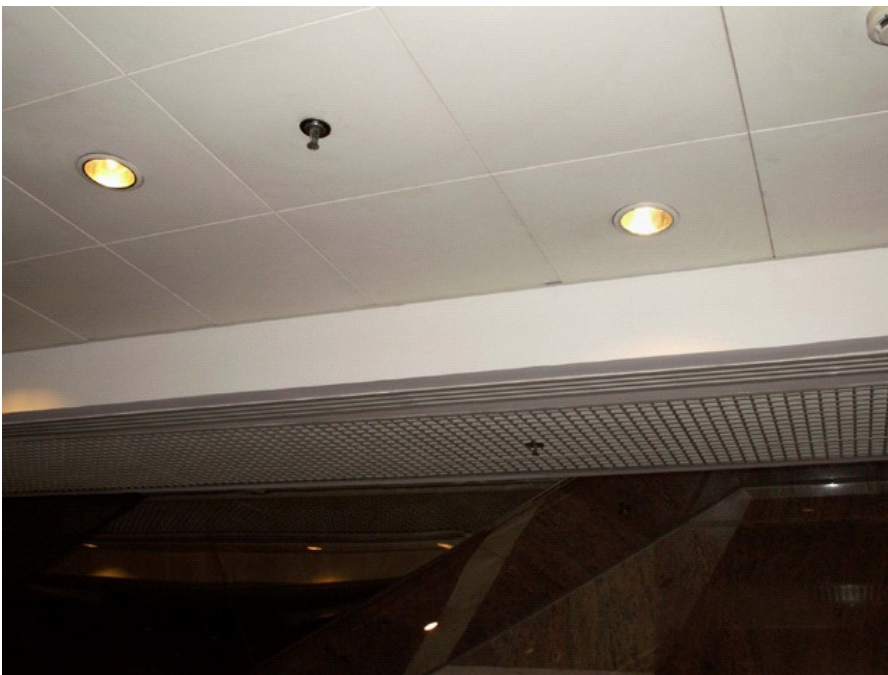
Sprinkler head clear of any obstruction

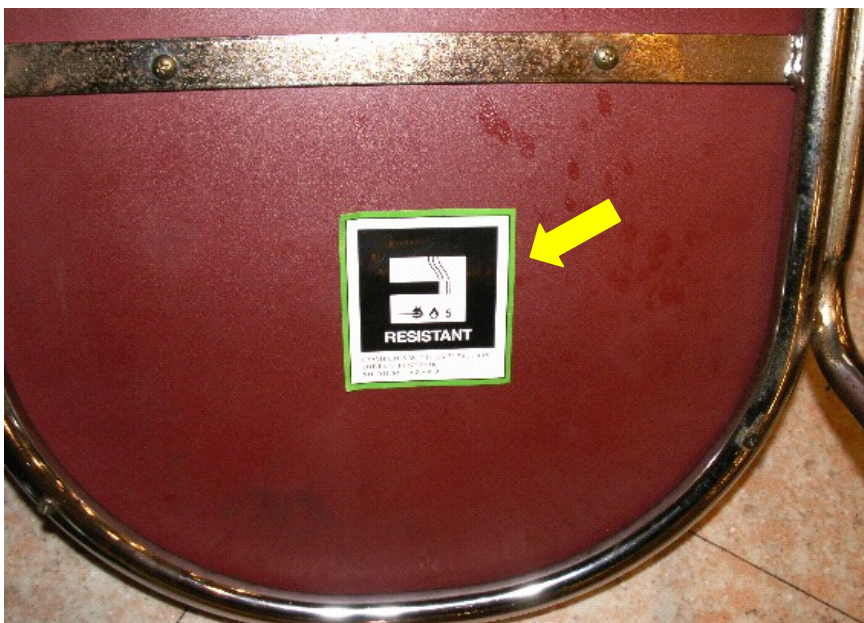
PU foam filled furniture comply with the British Standard 7176 :1995 (medium hazard) or British Standard 7177: 1996 (medium hazard)

Irregularities	<b>No documentary proof for fabric of PU foam filled furniture</b>
Advice	According to licensing requirements, all PU foam filled furniture should comply with the British Standard 7176 :1995 (medium hazard) or British Standard 7177: 1996 (medium hazard). For full compliance with PU foam filled requirements, a test certificate from recognized laboratory and an invoice from the supplier or manufacturer should be produced for verification purpose.
Irregularities	<b>Exit signs not conform to Fire Services requirements</b>
Advice	The design of the exit sign should be in accordance the current fire safety requirements.

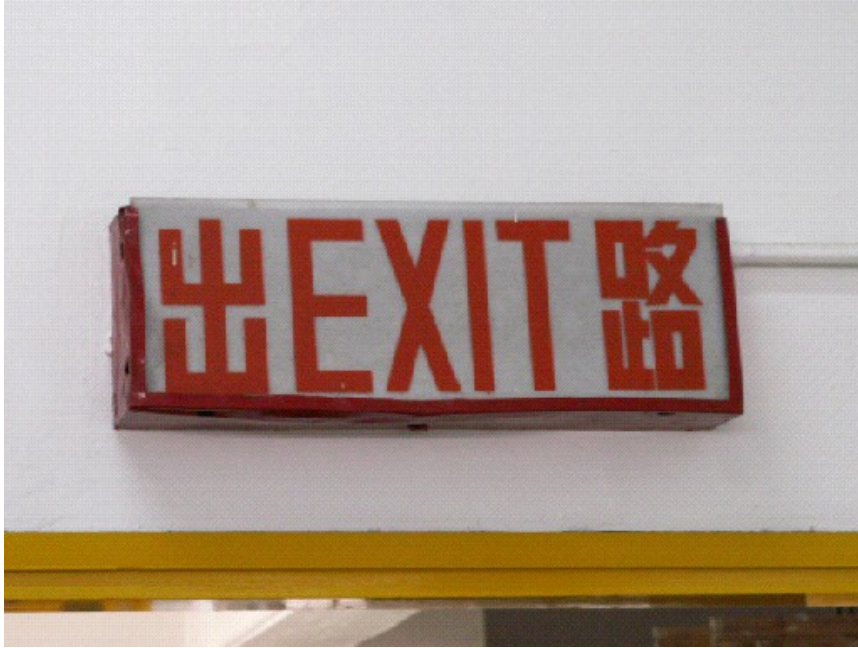
Exit sign not conforms to Fire Services requirements

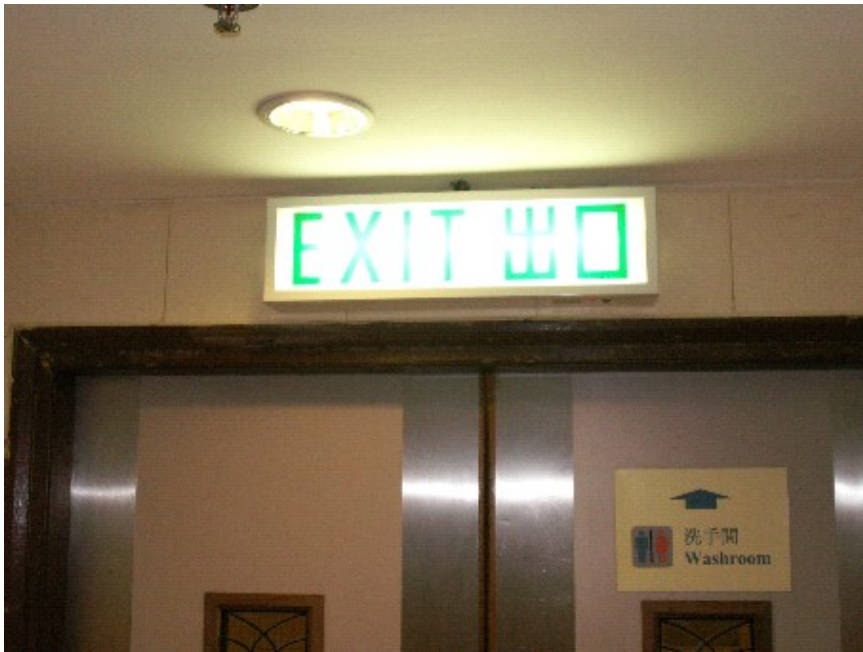
Exit sign conforms to Fire Services requirements
