Common Irregularities Encountered In the Issue of a Fire Services Certificate

Premises: Places of Public Entertainment (such as Dancing Establishment, Dance Parties and Entertainment Machine Centres)

Example of Common Irregularities

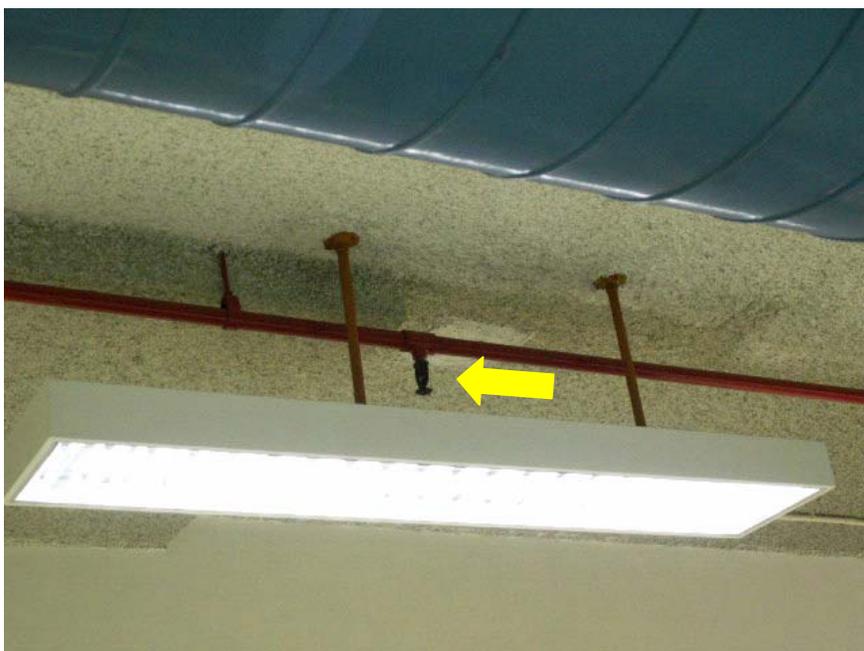
Obstruction to sprinkler head

Subject	Irregularities/Suggestions
<p>Irregularities</p> <p>Advice</p>	<p>Relocation of sprinkler heads without the production of a valid FSI/314A or FSI/314B</p> <p>For every minor alteration and addition works on the sprinkler system of the existing premises, a certificate of FSI/314A or FSI/314B as appropriate must be submitted by the Fire Service Installation Contractor to the Fire Services Department prior to the commencement of works. During the compliance inspection, a copy of the certificate of FSI/314A or FSI/314 B duly stamped by the Fire Services Department must be produced for verification purpose.</p>
<p>Irregularities</p> <p>Advice</p>	<p>Inadequate coverage of sprinkler heads or obstruction to sprinkler heads</p> <p>The main function of sprinkler heads is to suppress a fire at the incipient stage upon actuation. According to international standards, sprinkler heads should be evenly installed throughout the entire area under protection. For decoration works involving the removal or addition of partitioning walls, adequate coverage of sprinkler heads must be maintained and checked by a Registered Fire Service Installation Contractor. In any case, the operation of sprinkler heads should not be obstructed by any decoration, false ceiling, structure, stacking up of goods, etc.</p>

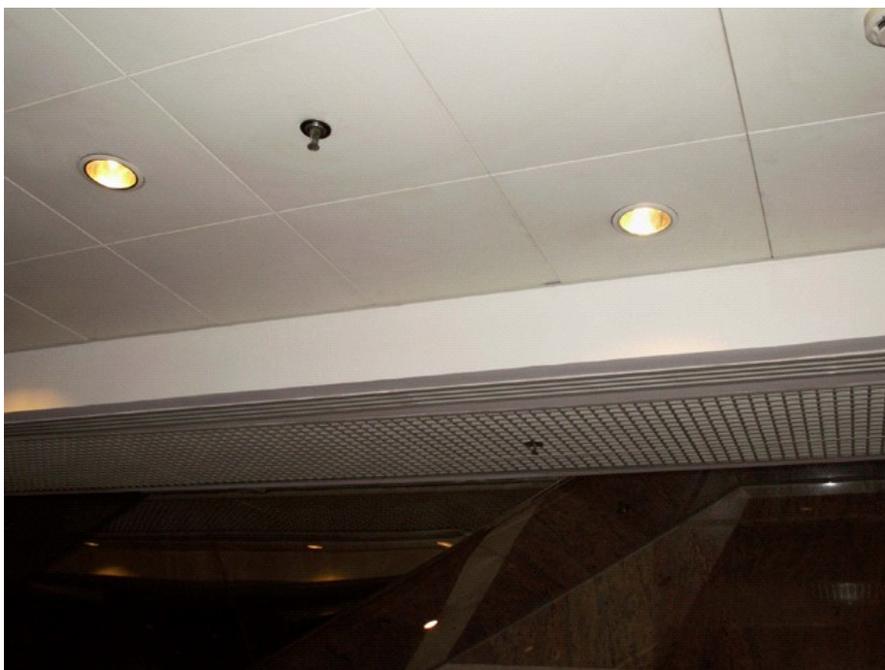
Sprinkler head clear of any obstruction

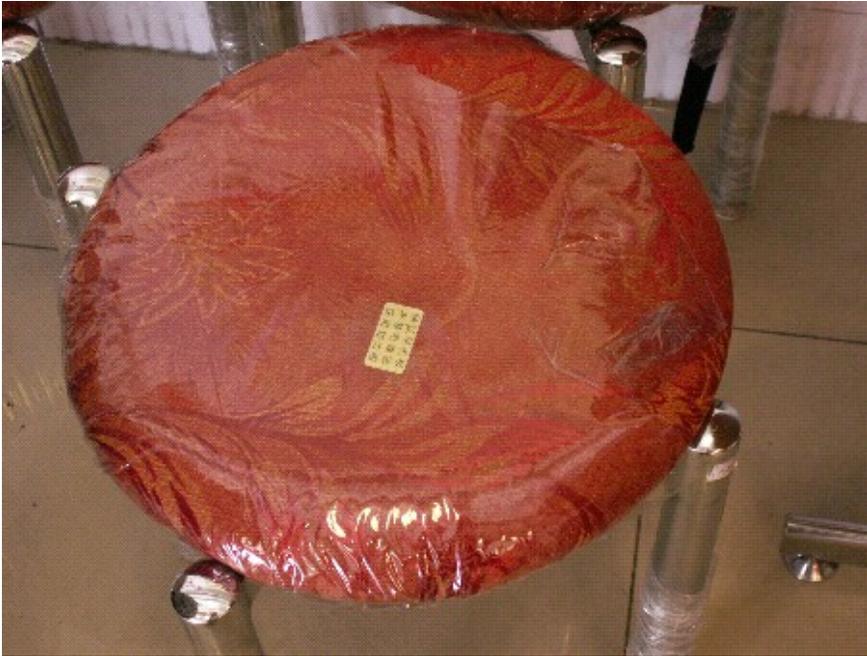
PU foam filled furniture not comply with the British Standard 7176 :1995 (medium hazard) or British Standard 7177: 1996 (medium hazard)

<p>Irregularities</p> <p>Advice</p>	<p>No documentary proof for fabric of PU foam filled furniture</p> <p>According to licensing requirements, all PU foam filled furniture should comply with the British Standard 7176 :1995 (medium hazard) or British Standard 7177: 1996 (medium hazard). For full compliance with PU foam filled requirements, a test certificate from recognized laboratory and an invoice from the supplier or manufacturer should be produced for verification purpose.</p>
<p>Irregularities</p> <p>Advice</p>	<p>No documentation to prove secondary lighting conforms to approved standard and insufficient information on FS 251</p> <p>For verification purpose, documentary proofs e.g. test report/certificate, etc. should be produced to indicate that the emergency lighting conforms to an approved or acceptable standard. The brand name, model and quantity of the emergency lighting units should be stated on FS 251.</p>

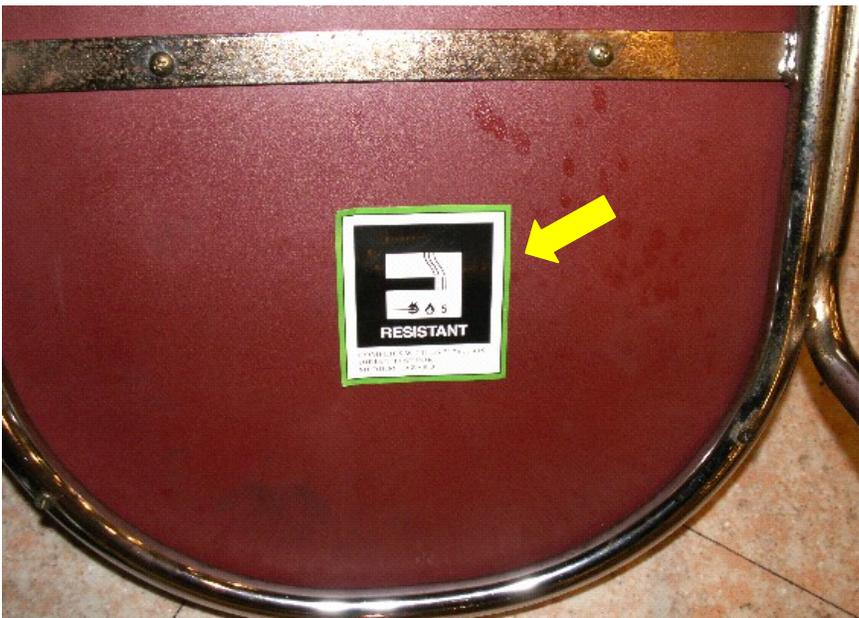
PU foam filled furniture comply with the British Standard 7176 :1995 (medium hazard) or British Standard 7177: 1996 (medium hazard)

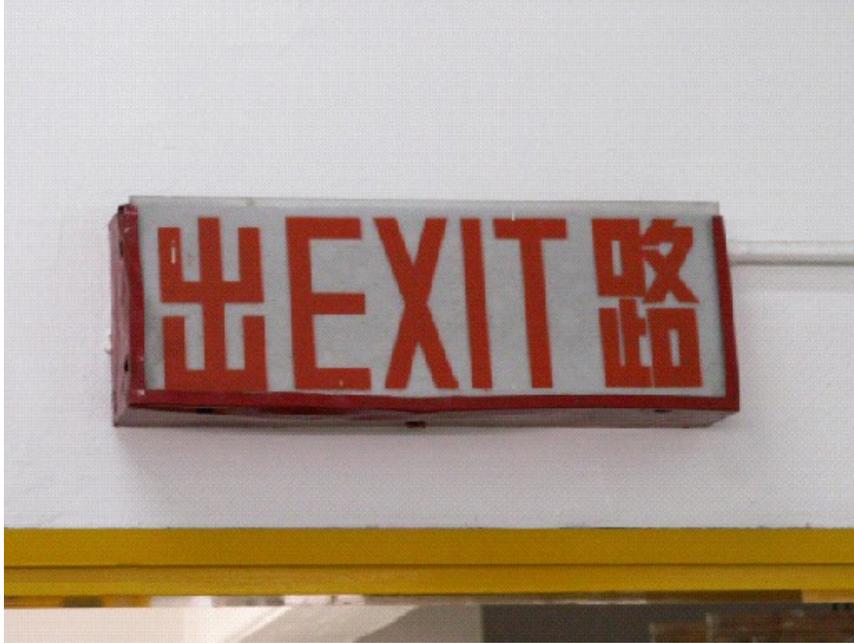
Exit sign not conforms to Fire Services requirements

Irregularities	Exit signs not conform to Fire Services requirements
Advice	The design of the exit sign should be in accordance the current fire safety requirements.

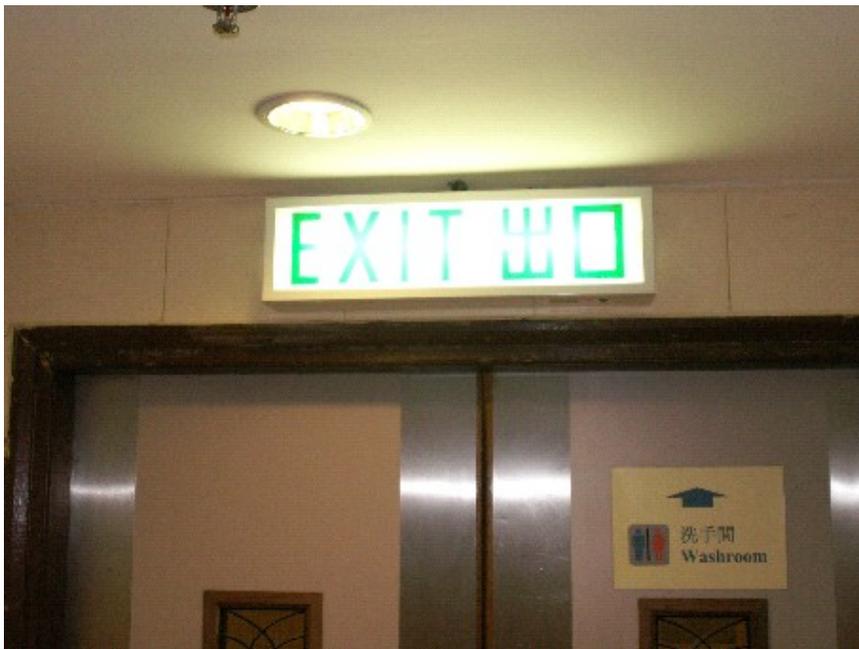
Exit sign conforms to Fire Services requirements
